# CONSEQUENCES OF NOT MAINTAINING ADEQUATE RAIL NEUTRAL TEMPERATURE

FRA Track Safety Symposium  
St. Louis, MO  
April 5, 2022

*Brad Kerchof*  
*Advanced Rail Management*  
*Norfolk Southern Railway (retired)*

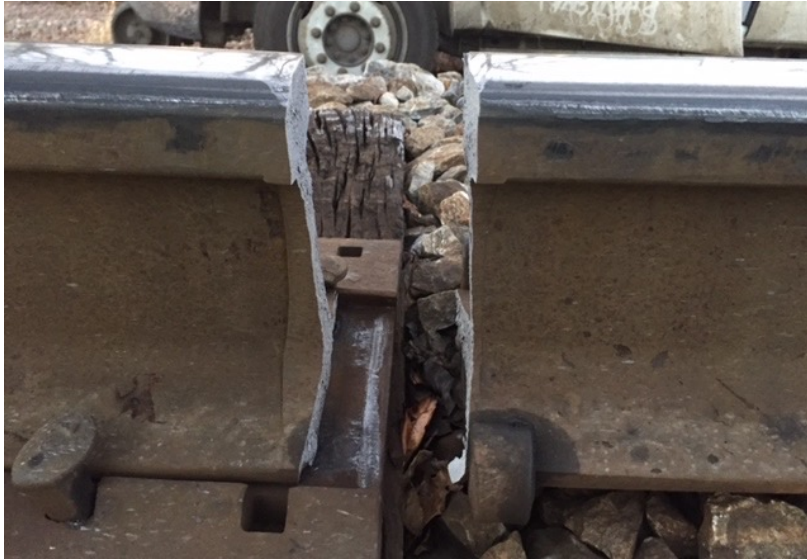
Repairing this broken weld will add close to 3 inches of rail (rail temp at the time was 20°F)

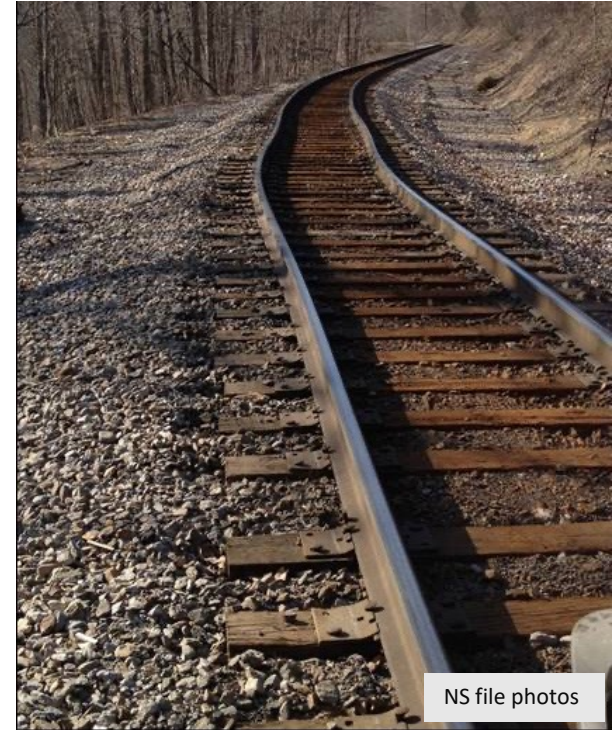
This curve pulled inward in cold weather (note voids at the ends of the ties)

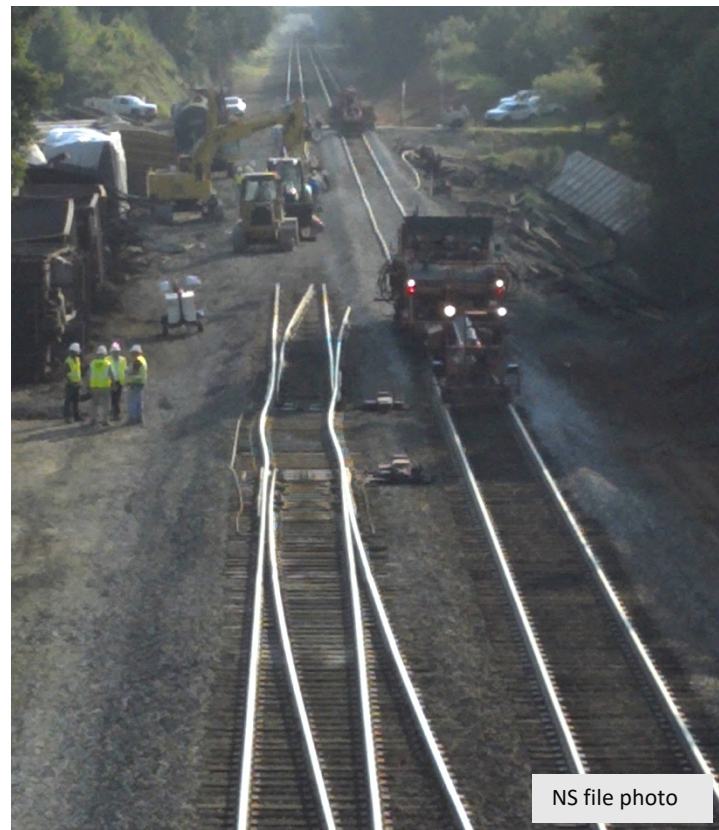
# CONSEQUENCE OF LOW RNT (#1)

- Preceding November – Installed 4 stock rails, 4 switch points & both rails between switches, rail temp 60°.
- January – A dozen thermite welds at temps between 14° and 53°; 2 inches added to each side, according to welders' rail-added reports.
- August 1 - Buckled track derailment, air temp 91°

- RNT est. 20° - 50°, actual rail temp 110°,  $\Delta T > 60^\circ$

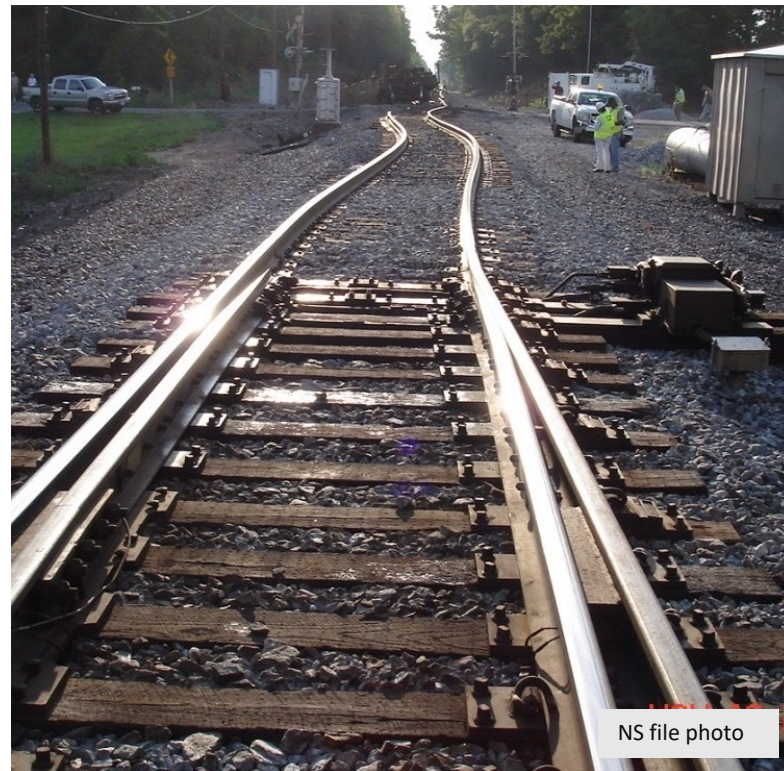
## CONSEQUENCE OF LOW RNT (#2)

- February – Removed a no. 20 turnout, installed a no. 10 turnout and 3 track panels. Temperature was in the upper 40's. No rail-added report.
- March – 18 thermite welds at temps between 50° and 60°. No rail-added report.
- May 16 – Buckled track derailment, air temp 83°

- RNT est. 50°, actual rail temp 110°,  $\Delta T$  60°

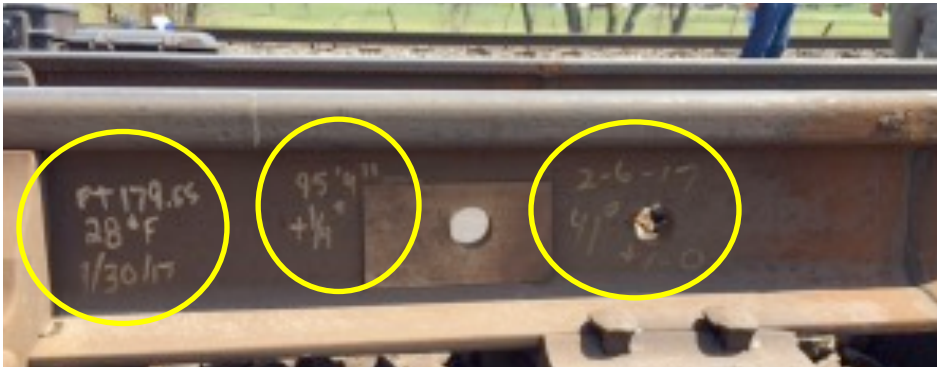
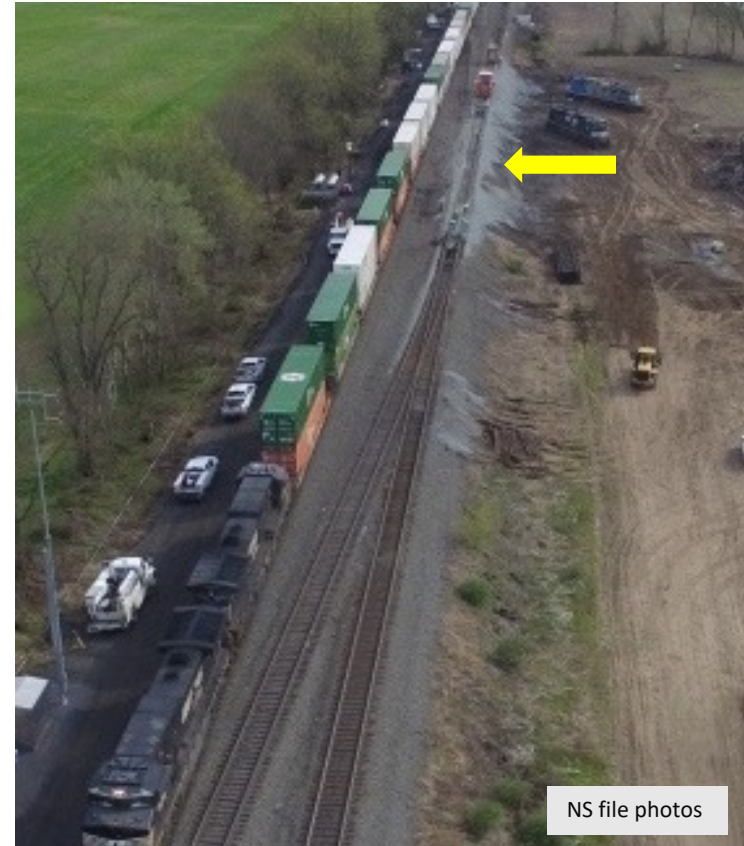
## CONSEQUENCE OF LOW RNT (#3)

- January - Installed two 95-ft rails between two no. 20 turnouts, temp 28° N rail and 44° S rail; rail added 1/4" and 1/8".
- February – 6 thermite welds at 41°; 0" rail added.
- April 14 forecast – high temperature of 69°

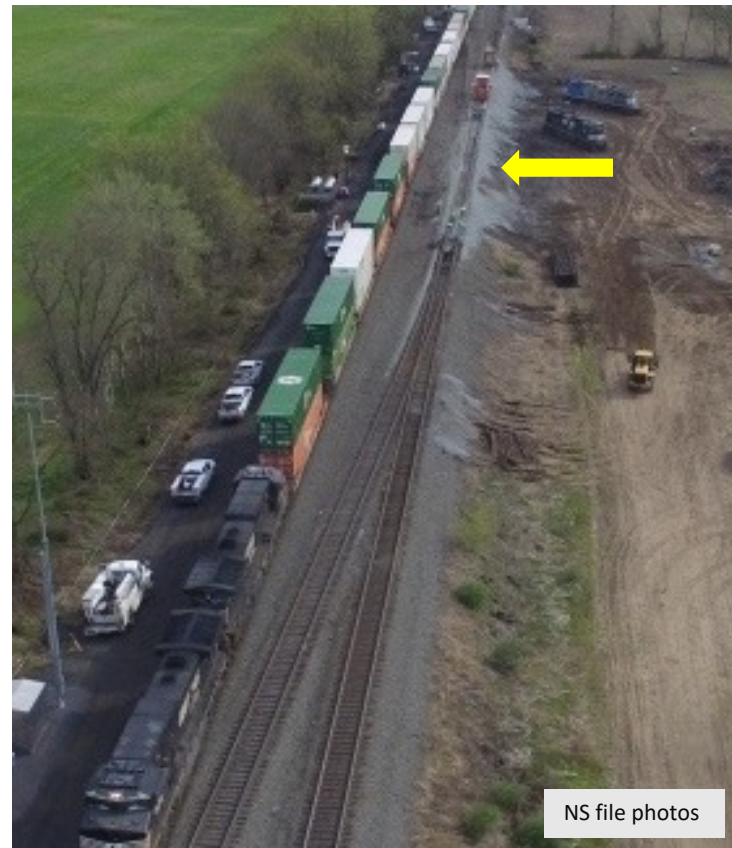
## CONSEQUENCE OF LOW RNT (#3)

- January - Installed two 95-ft rails between two no. 20 turnouts, temps 28° N rail and 44° S rail
- February - Thermite welds at 41°
- April 14 – **Buckled track derailment, air temp 69°**

- RNT 28° - 44°, actual rail temp est. 95° by ENSCO rail prediction model,  $\Delta T$  60°

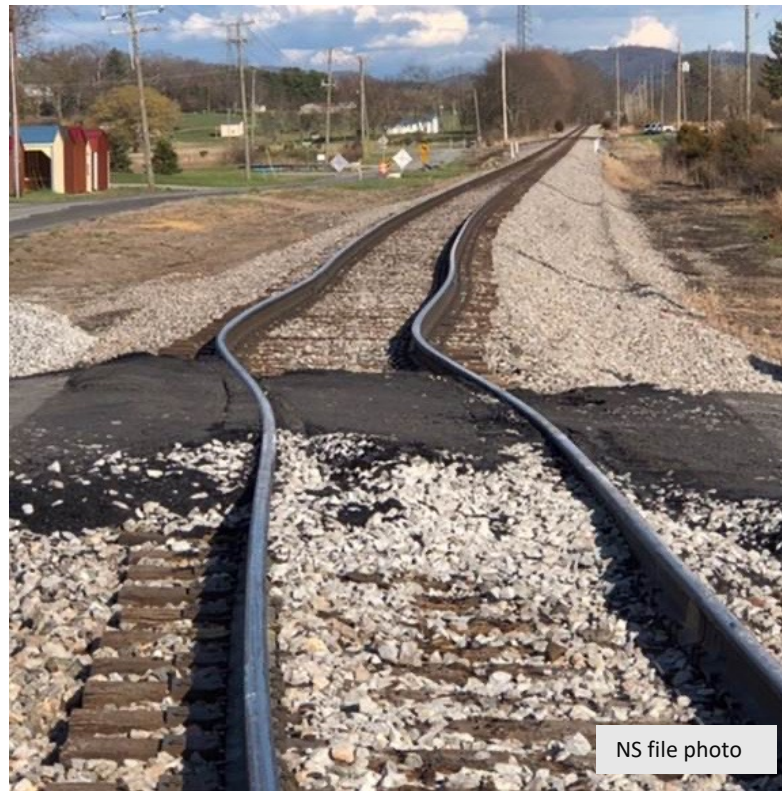
## CONSEQUENCE OF LOW RNT (#4)

- Preceding November - Installed 42 ft. rails on H and L sides through crossing; joints thermite welded; temp < 30° for all of this work.
- January – Changed out Sperry rail adjacent to crossing on H rail; joints thermite welded; temp < 30°.
- Crossing was on the supervisor's rail-added list; adjustment waiting for warm weather.
- April 6 forecast: temperature in the mid 60's

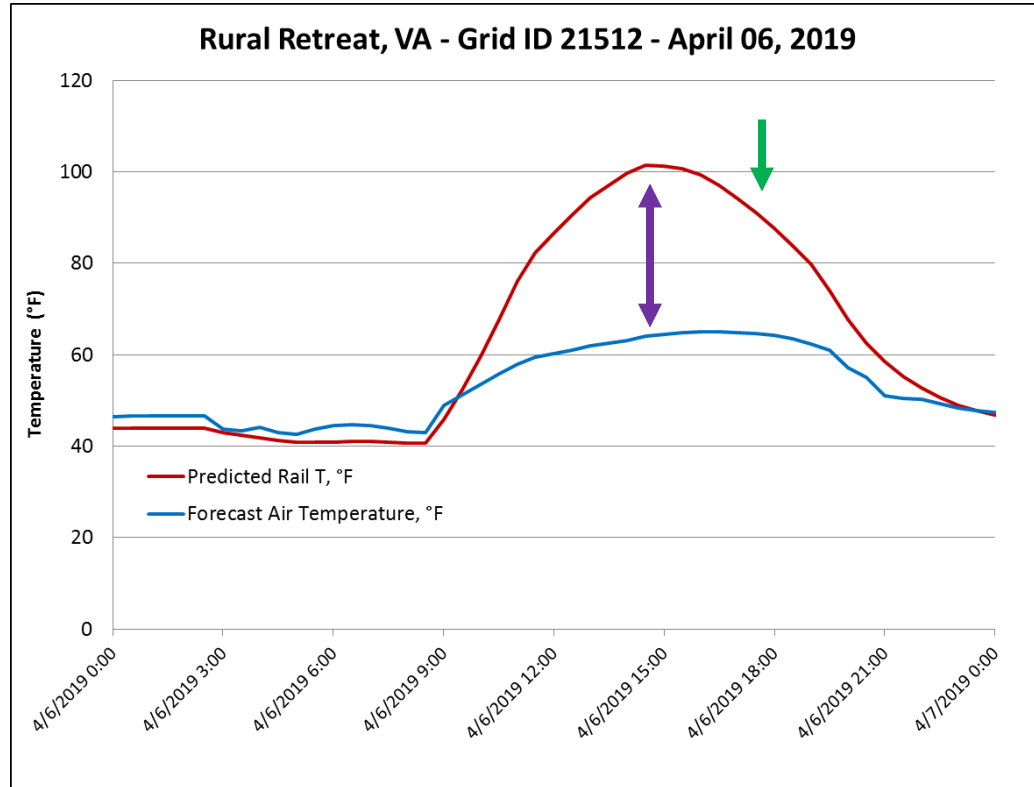
## ENSCO RAIL TEMPERATURE PREDICTION MODEL (#4)

- The accuracy of the model was validated when we measured actual rail temp of 88° at 6:00 pm
- Note difference between ambient (64°) and predicted rail temp (101°) at 3:00 pm (time of derailment)
- The impact of solar radiation was substantial – predicted rail temp was 37° above ambient

- RNT < 30°, actual rail temp est. 101° by ENSCO model,  $\Delta T > 60^\circ$

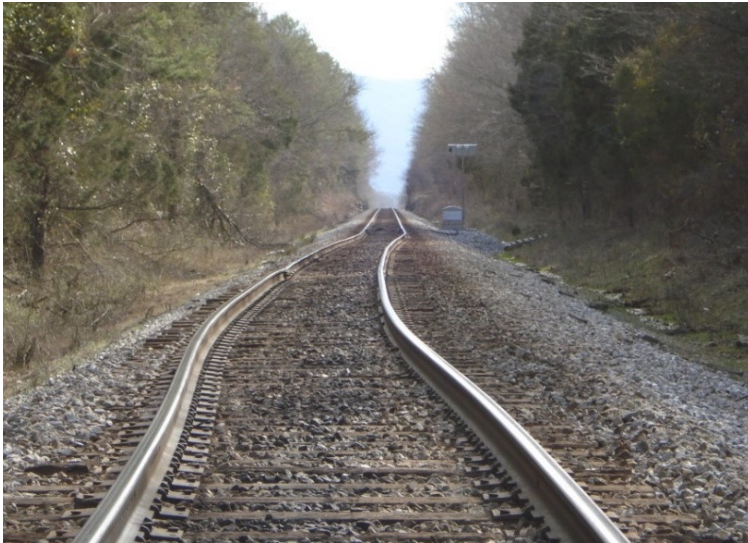
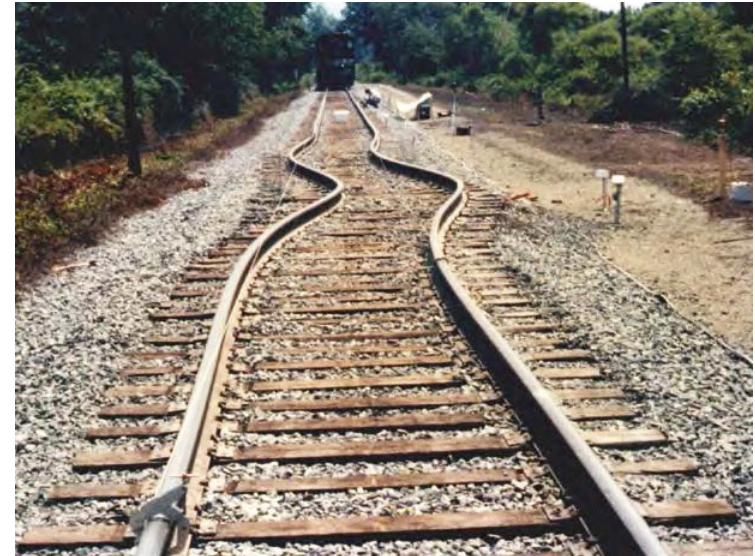
This misalignment is not a heat buckle – its shape is not the typical “S” found in tangent track (like the heat kink above).

Rather, this misalignment was caused by a severe train run-in, which pushed two-car lengths of track to one side.
